ASTC/USITT Renovation Challenge
Oberlin College and Conservatory

Warner Center

Project Scope

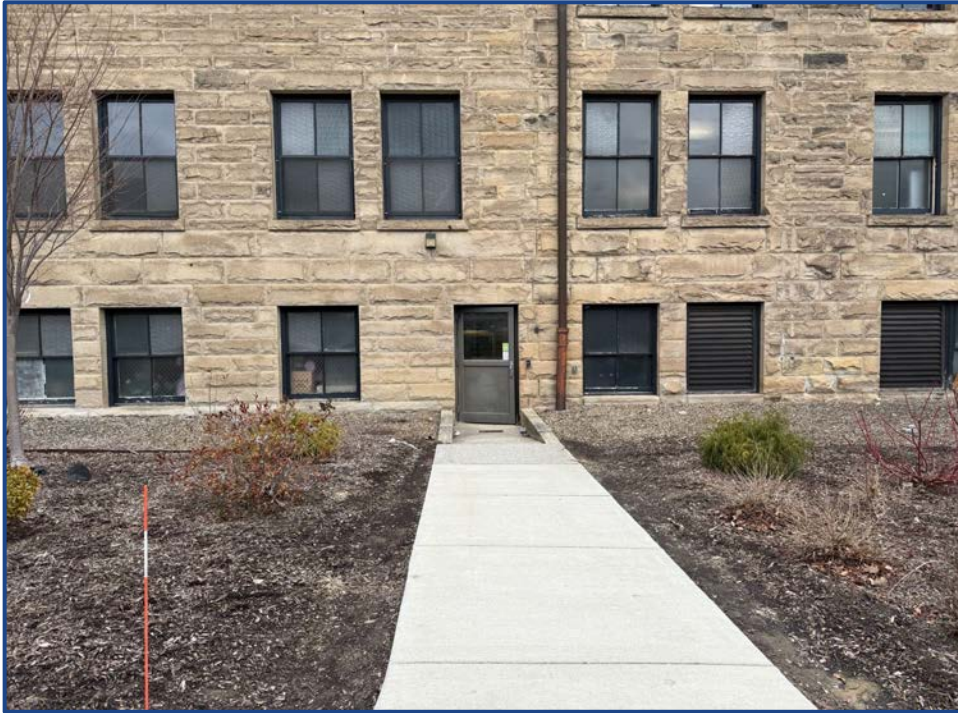
Accessibility – Entrance Problems cont.

Back entrance has ramp but opens to stairs leading to basement level.

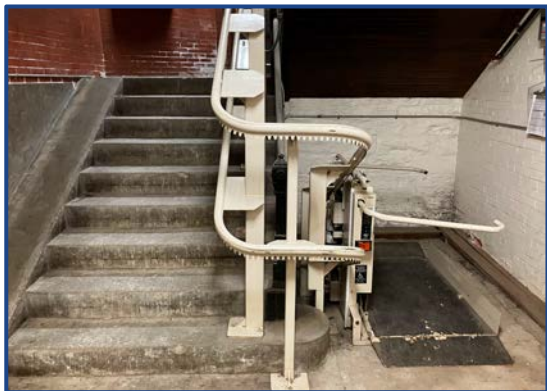
Existing Chair Lift

Chair lift is stored at the basement level, and cannot be accessed by an individual wheelchair-bound person.

Violates ADA code 410.1

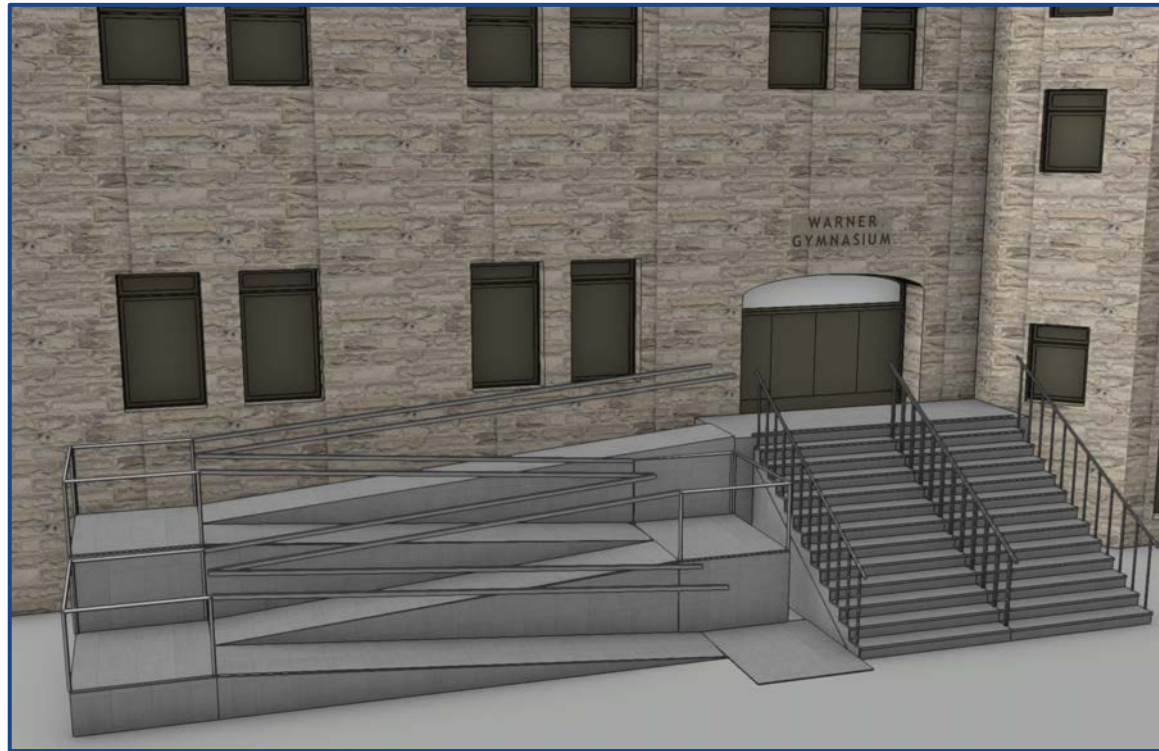
Proposed staircase renovation with ramp addition

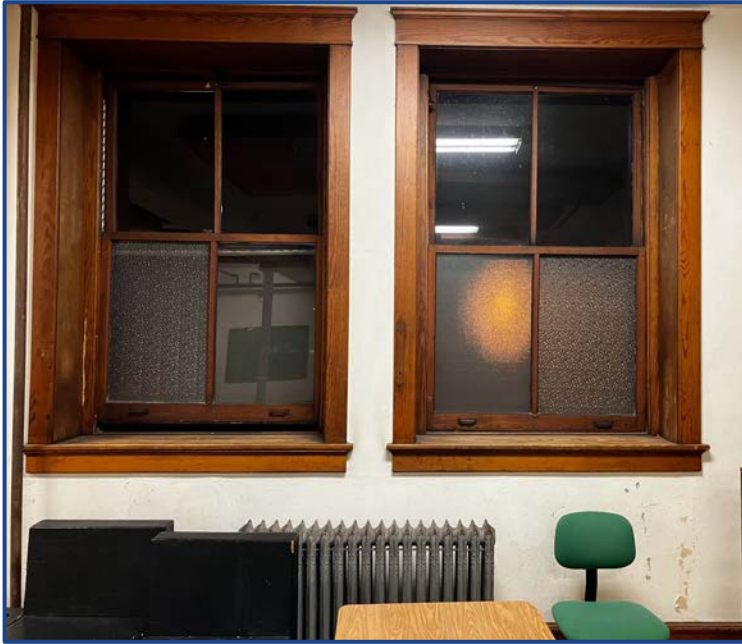
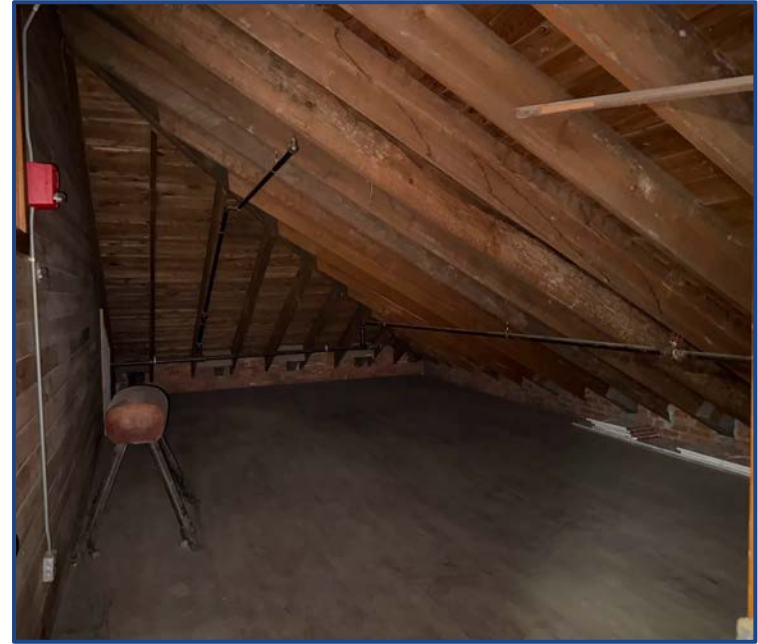
Sustainability – Problems

Currently, Warner Center has no ventilation system and the HVAC is original. Single-paned windows with imperfect fittings leak cold air in, while an uninsulated roof lets warmth out. Both these factors dramatically impact building energy efficiency.

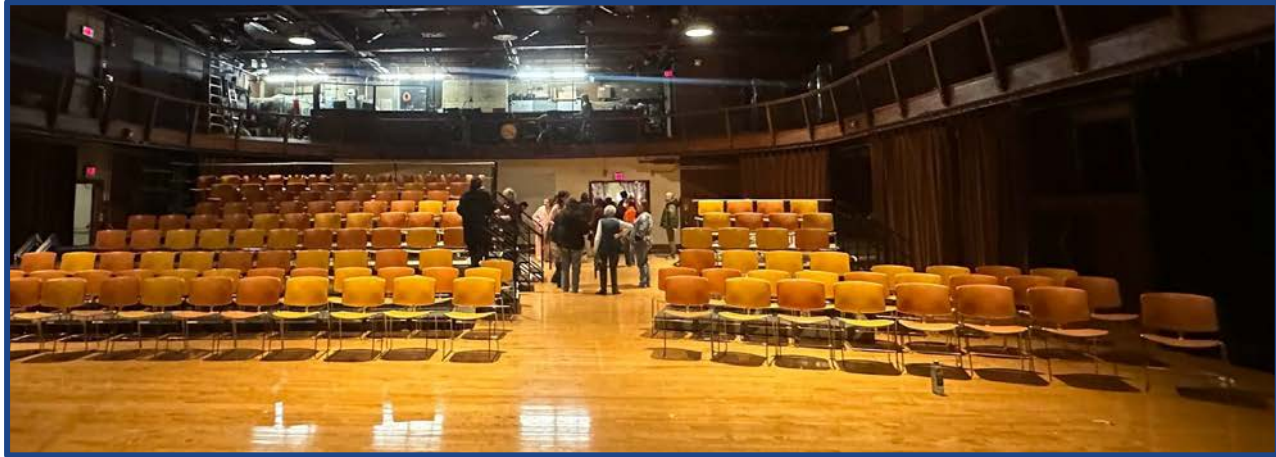
Current Warner Main seating uses portable, collapsible stage risers.

Time consuming, difficult, and labor intensive.

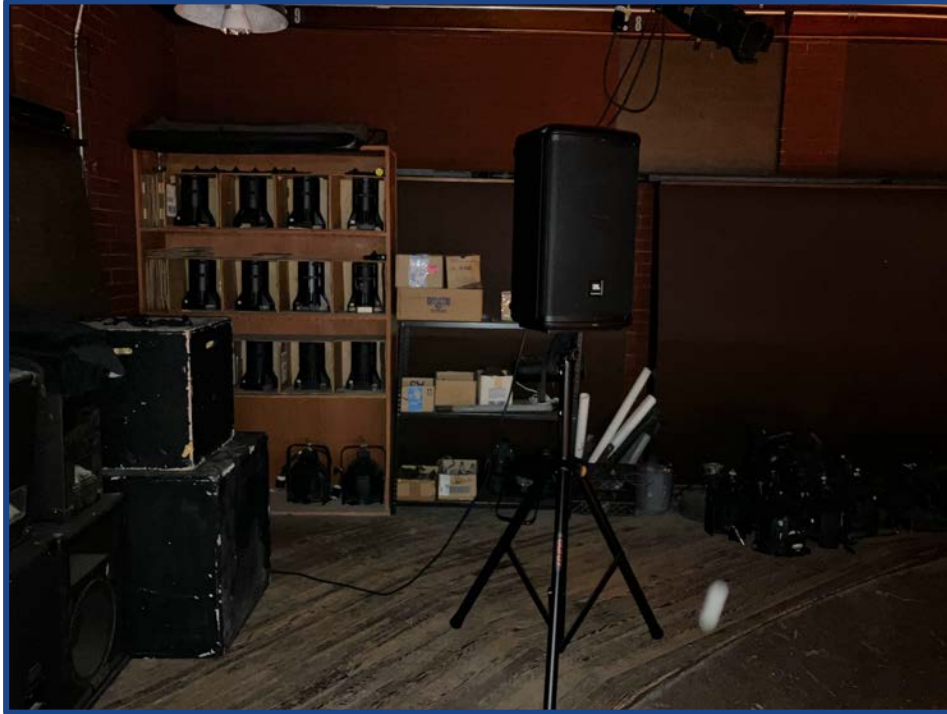
Current sound system along historic running track

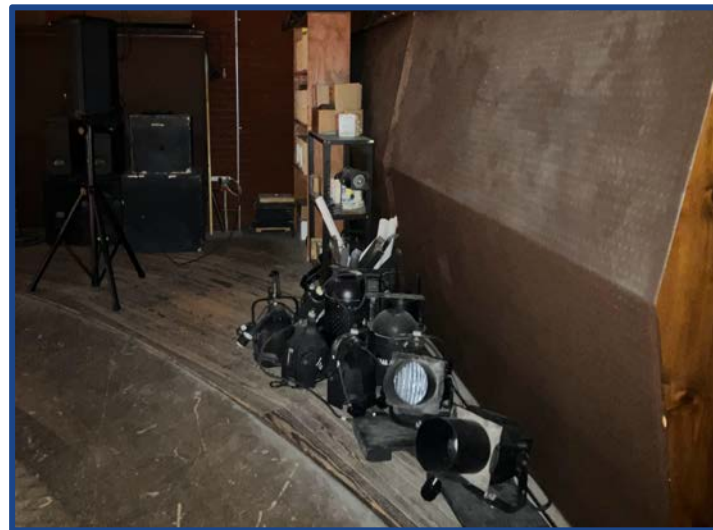
Warner Main Lighting System

- **Unistrut**, presents difficulties with fixture hang and focus
- **Mix of installed and portable dimmers**

- **Inadequate storage options** (along the corners of the running track)
